Alaska Airlines Flight 1282

| Summary | <u>Uncontrolled decompression</u> after loss of incorrectly installed door plug |

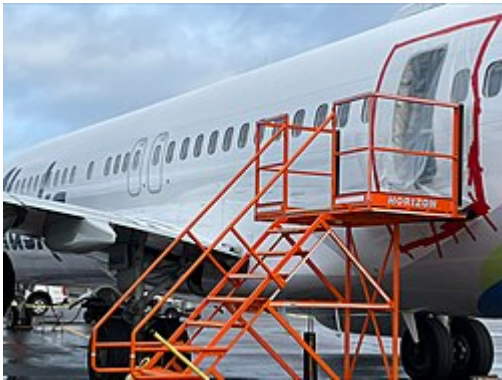
The aircraft, photographed on January 7, with plastic sheeting covering the missing door plug

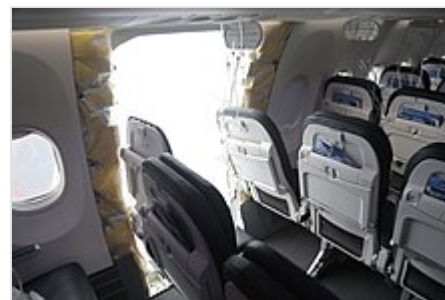
Interior view from after the accident showing the missing door plug and damaged seats

Interior non-structural damage was observed at rows 1 through 4, 11 and 12, 25 through 27, and 31 through 33, including damage to seat 25A, which lost its headrest and was itself twisted, and seat 26A, which lost its headrest and seatback cushion as well as the tray table on its rear side.^[23]

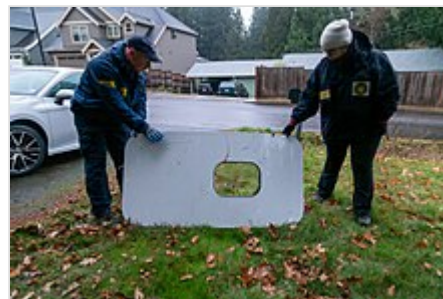
NTSB investigators with the door plug recovered from the backyard of a home in Cedar Mill, Oregon

The NTSB's initial assessment found that the stop pads and fittings of the door plug and frame were intact, and that the plug had moved upwards to clear the pads to enable its ejection from the aircraft.^[24] The upper guide fittings on the door plug were found to be fractured.^[24] Investigation on the status of the retention bolts designed to prevent the door plug from moving upwards is ongoing. By design, four retention bolts should be present. Homendy said the bolts were not on the door plug when it was found. She said investigators are trying to determine if the bolts were never installed or if they were torn off when the door plug blew out.^[9] The NTSB will also examine witness marks using microscopes and other scientific equipment.^[24]

The NTSB released a preliminary report on the accident on February 6, which said that the damage patterns on the door plug indicated that the four bolts, intended to secure the door plug, had been missing when the accident occurred. They also reviewed Boeing records that showed evidence that the plug had been installed with no bolts.^[4]

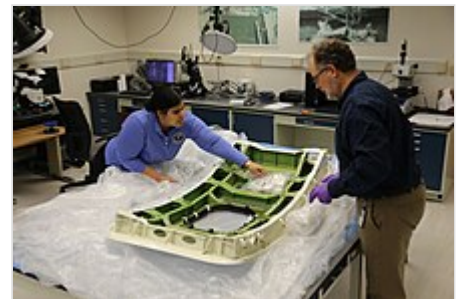
NTSB staff examine the door plug in the NTSB materials laboratory
