Alaska Airlines Flight 1282

| Summary | <u>Uncontrolled decompression</u> after loss of incorrectly installed door plug |

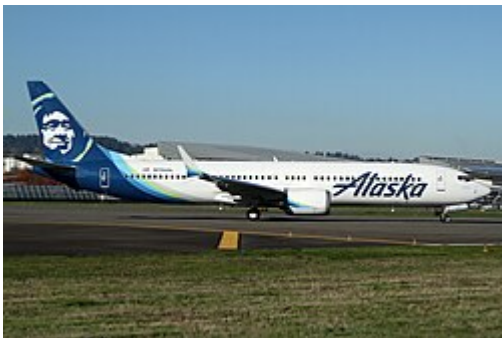
N704AL, the aircraft involved in the accident

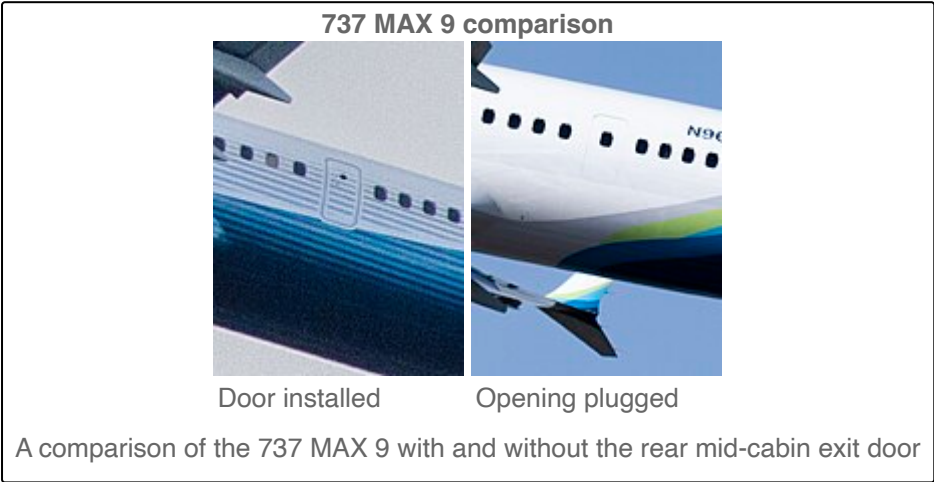
The door plug was manufactured by Spirit AeroSystems in Malaysia on March 24, 2023. It arrived at Spirit's factory in Wichita, Kansas, on May 10, where the fuselage was assembled. It was installed on the fuselage before it was shipped by train on August 20 for final assembly at the Boeing Renton Factory in Renton, Washington, where it arrived

After the fuselage arrived at the Boeing Renton Factory, five damaged rivets were found on the fuselage near the door plugs. The plug was removed so that Spirit AeroSystems employees could fix the rivets. Once the repair was made, the door was reinstalled, but not bolted into place.^[4]

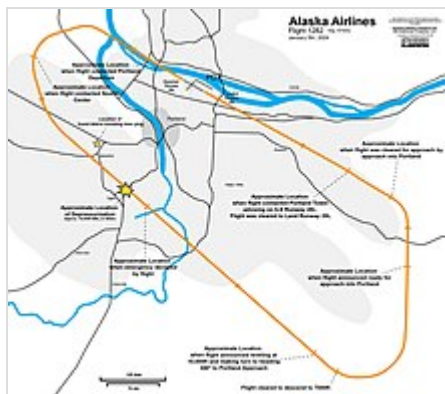
Approximately six and a half minutes after takeoff, the factory-installed door plug filling the port-side opening for the optional emergency exit door separated from the airframe, causing an uncontrolled decompression of the aircraft.^{[6][15]} The aircraft's oxygen masks deployed during the

Flight path illustration of Alaska Airlines Flight 1282
